**AIRCRAFT ACCIDENT
IDENTIFICATION
NO.**

NAVAL AVIATION SAFETY CENTER

16. TIME IN FLIGHT 01:41	17. TYPE ACCIDENT A-1, 6-8 in air, collision	18. PHASE OF FLIGHT 4 in flight		
19. MODEL F8U-2	20. SERIAL NO. 146975	21. DAMAGE TO A/C <input checked="" type="checkbox"/> A <input type="checkbox"/> B <input type="checkbox"/> C <input type="checkbox"/> D <input type="checkbox"/> E <input type="checkbox"/> F <input type="checkbox"/> G <input type="checkbox"/> H <input type="checkbox"/> I <input type="checkbox"/> J <input type="checkbox"/> K <input type="checkbox"/> L <input type="checkbox"/> M <input type="checkbox"/> N <input type="checkbox"/> O <input type="checkbox"/> P <input type="checkbox"/> Q <input type="checkbox"/> R <input type="checkbox"/> S <input type="checkbox"/> T <input type="checkbox"/> U <input type="checkbox"/> V <input type="checkbox"/> W <input type="checkbox"/> X <input type="checkbox"/> Y <input type="checkbox"/> Z	22. DOLLAR COST 999,000	23. AIRSPEED (Kts) 300

Both aircraft sustained Alfa damage as a result of the mid-air collision and subsequent impact with the ground.

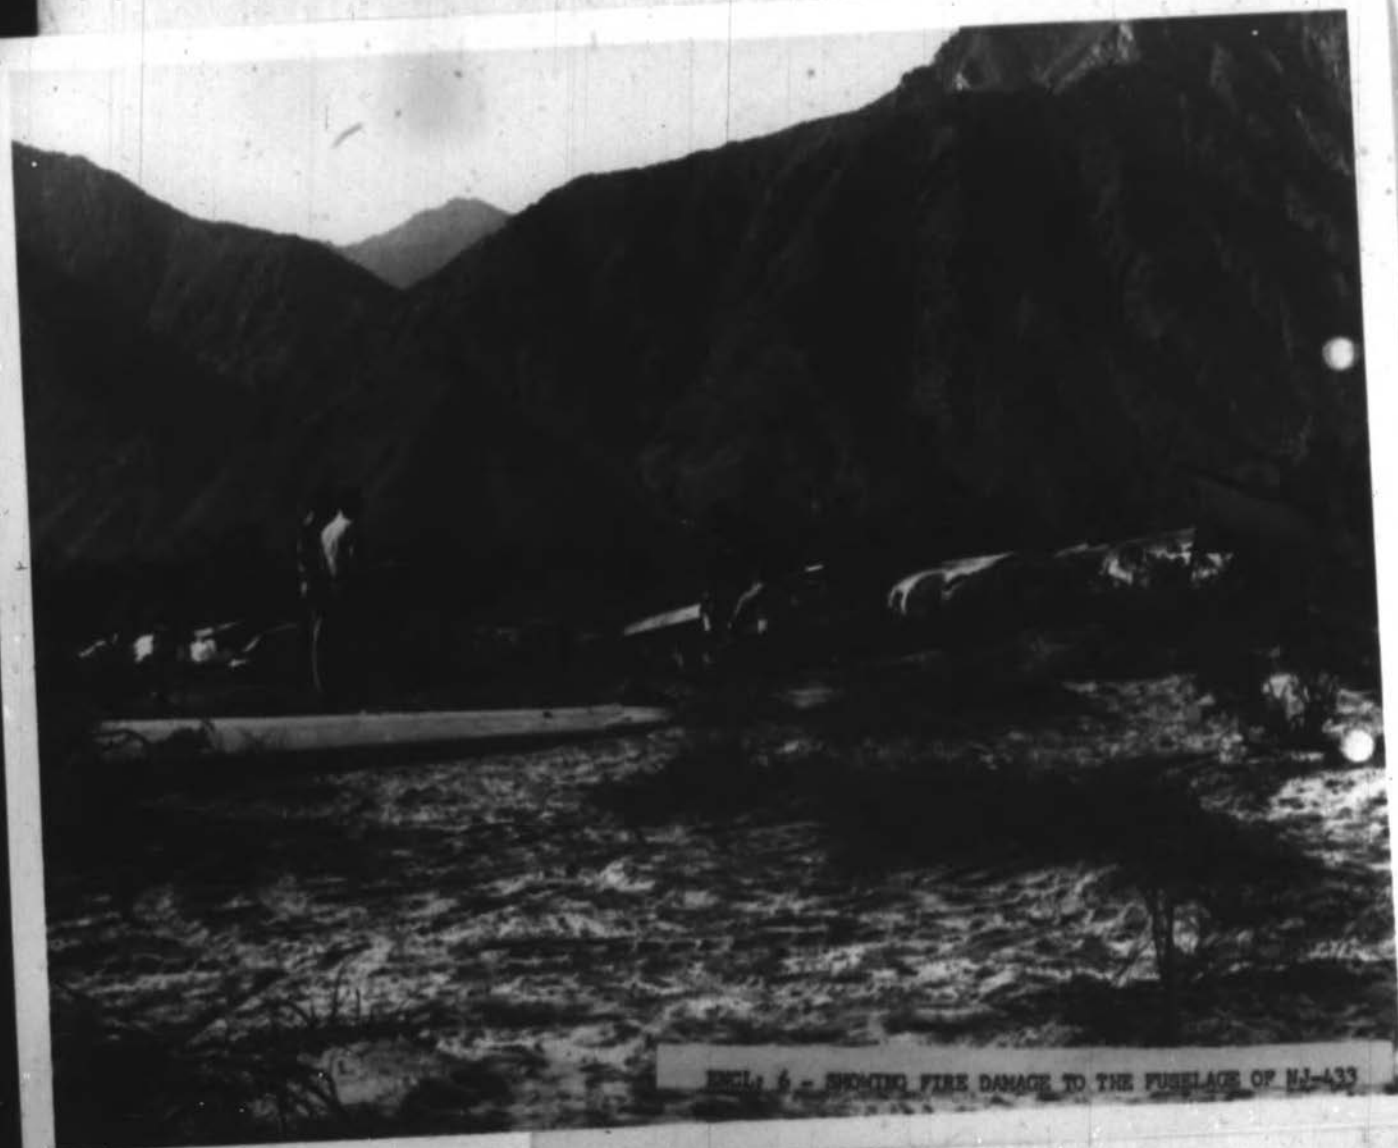
(1) Massive impact and fire damage to the fuselages of both aircraft from aft of the cockpit to just aft of the wing pivot fitting bulkhead. The cockpits and tail sections were recognizable but severely crushed. Fire broke out on impact and gutted the entire center section of both aircraft. There was no evidence of an inflight fire in either aircraft.

The fuselages of both aircraft were destroyed by fire from the wing pivot fitting rib forward to the aft bulkhead of the cockpit. (Encl: 6-7) The wing of NJ-408 though completely separated from the aircraft, was in relatively good condition as were the two sections of the wing from NJ-433. No evidence of inflight fire was discovered.

REEL: 6 - SHOWING FIRE DAMAGE TO THE FUSELAGE OF NJ-433

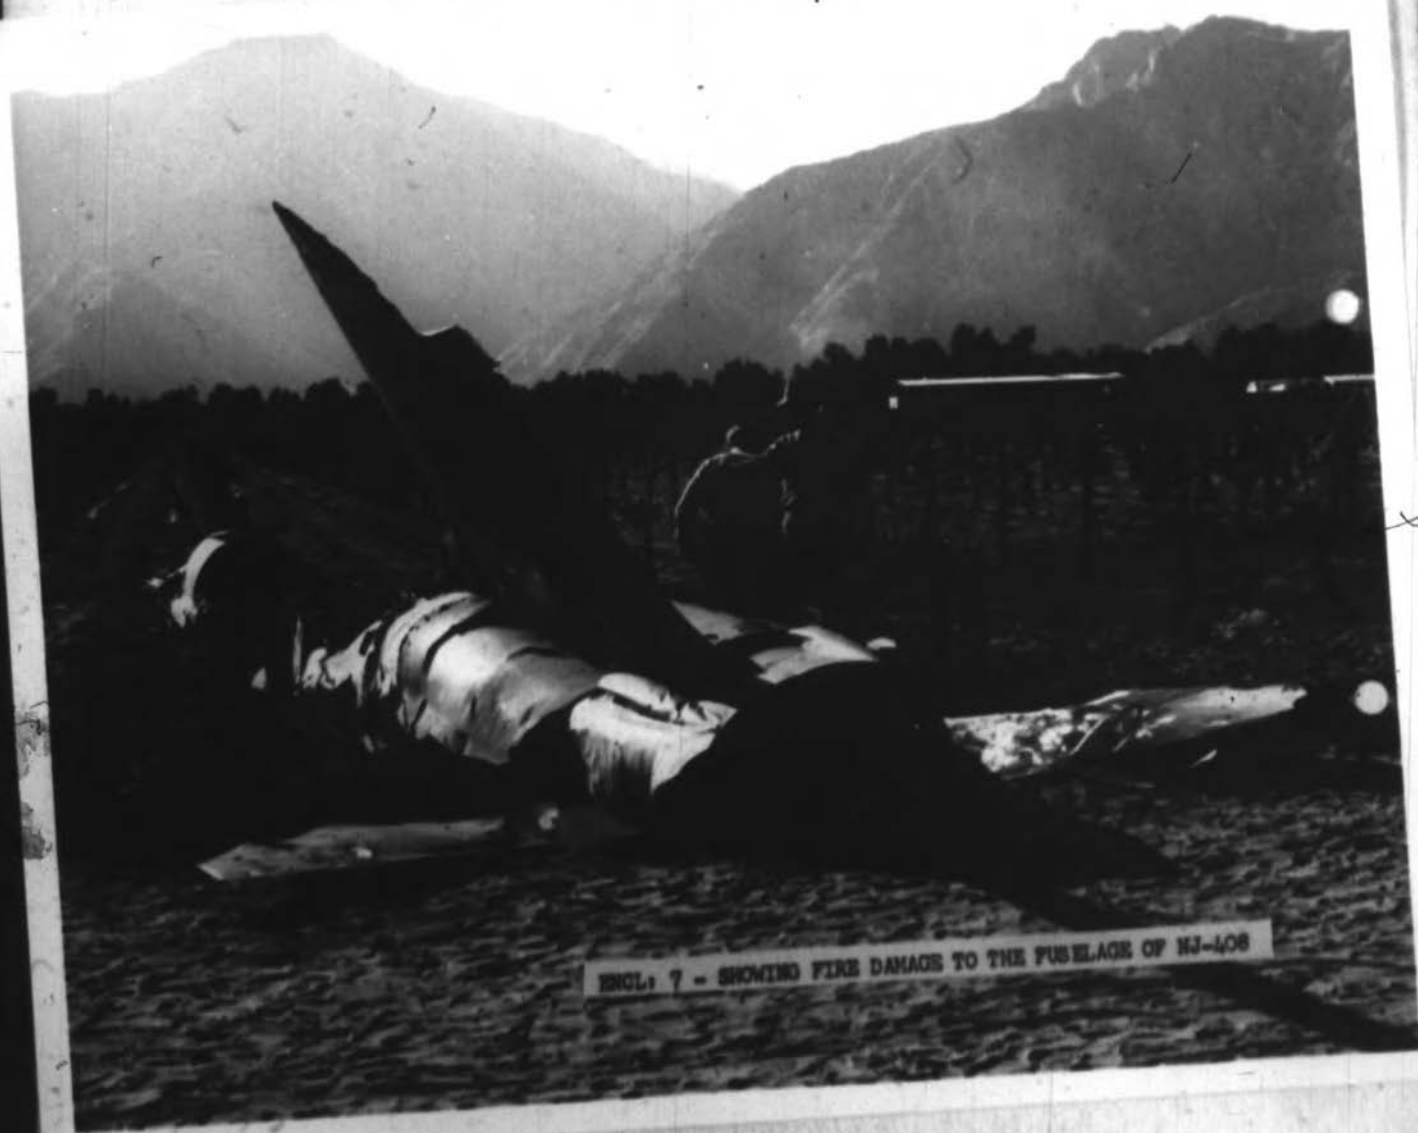
ENCL: 7 - SHOWING FIRE DAMAGE TO THE FUSELAGE OF NJ-408

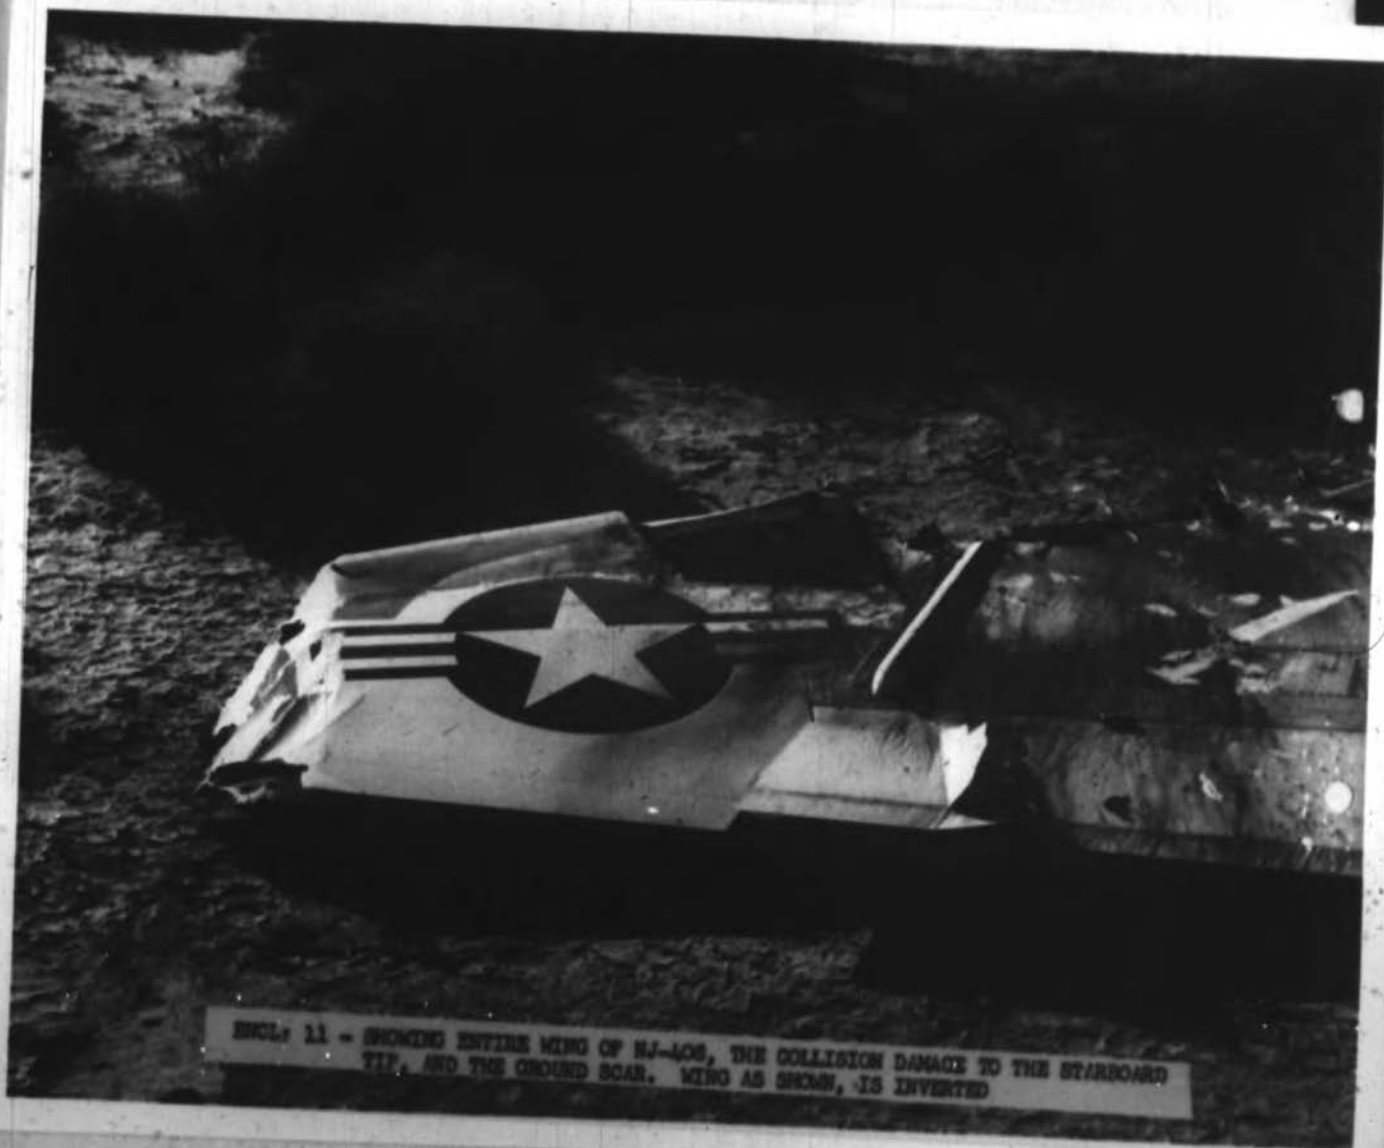
The starboard wing tip of NJ-408 was bent up by a collision inflight. This fact was verified by ground scars. The ground scar was caused by the wing of NJ-408 striking the ground leading edge first with the starboard half making initial contact. The resulting ground scar is in the form of a narrow, straight trough with a 60° curve approximately two feet from the starboard end. (Encl: 11) This substantiates the conclusion that the starboard wing tip was, in fact, bent upward prior to impact with the ground. The starboard wing tip of NJ-408 had red white and blue paint marks on the curled up portion. These marks had to come from the star insignia on the fuselage of NJ-433. The paint marks and ground collision marks indicate a collision between the fuselage (in the area of the star insignia) of NJ-433 and the wing tip of NJ-408.

ENCL. 11 - SHOWING ENTIRE WING OF NJ-406, THE COLLISION DAMAGE TO THE STARBOARD TIP, AND THE GROUND SCAR. WING AS SHOWN, IS INVERTED

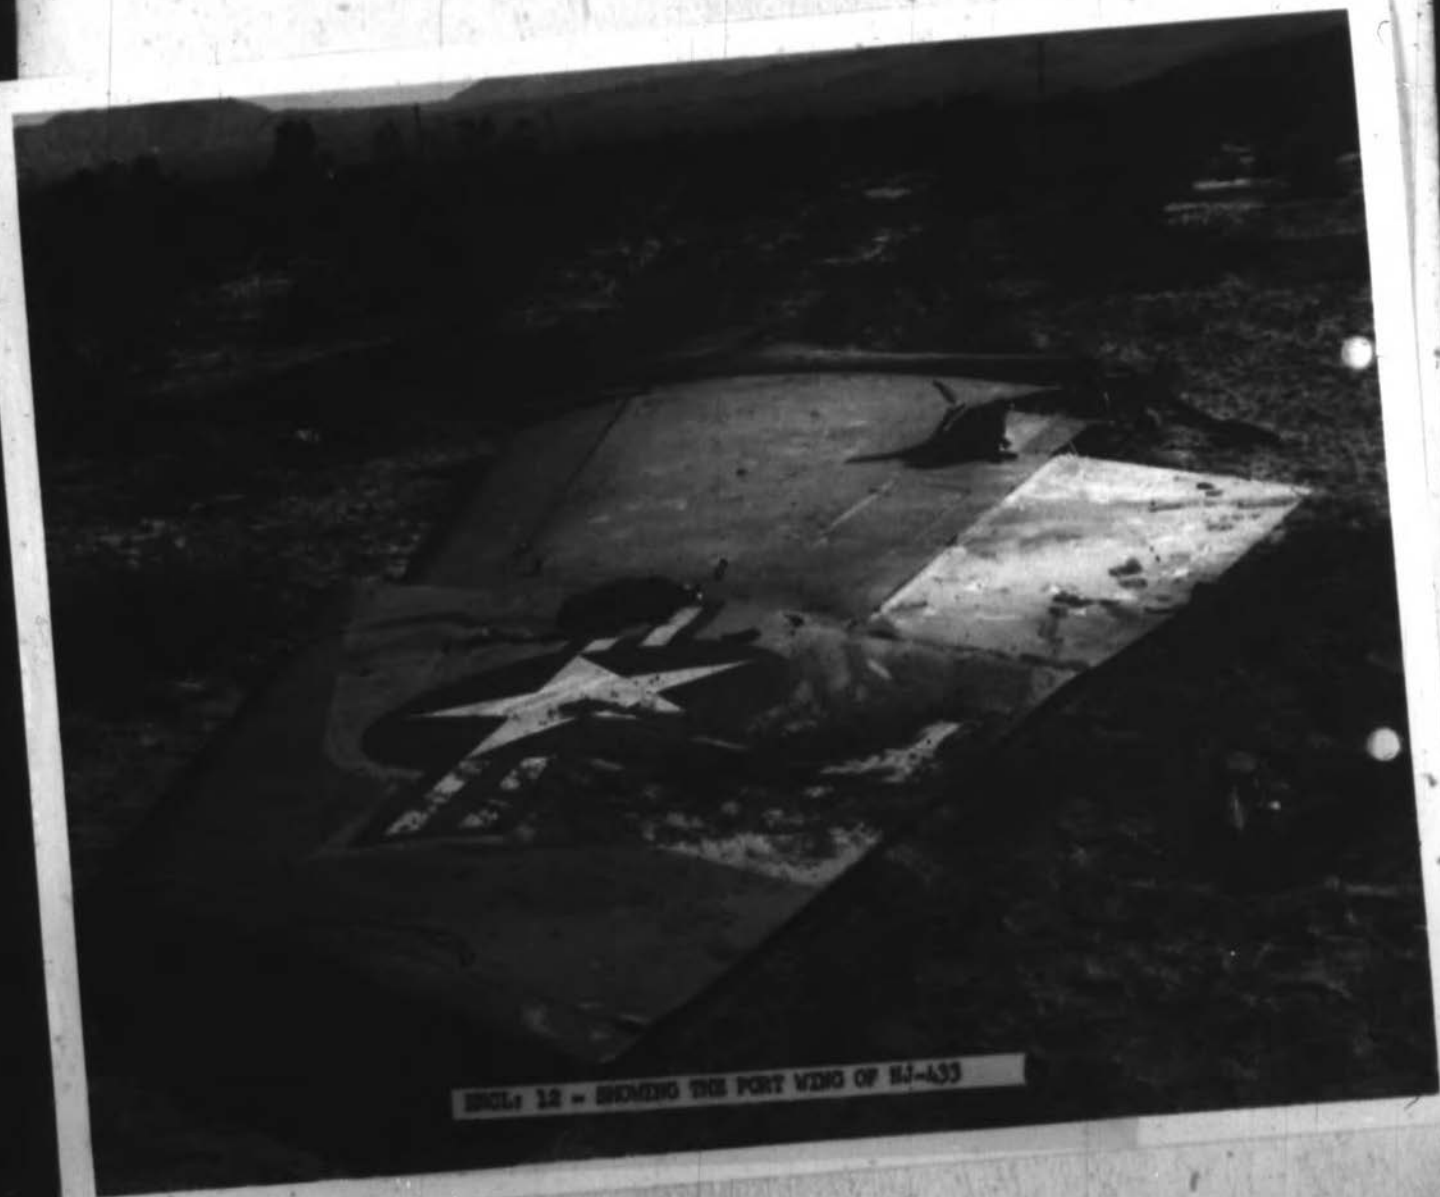
The port wing of NJ-433 was virtually intact and showed no evidence of inflight damage (Encl: 12).

INCL: 12 - SHOWING THE PORT VIEW OF HJ-433

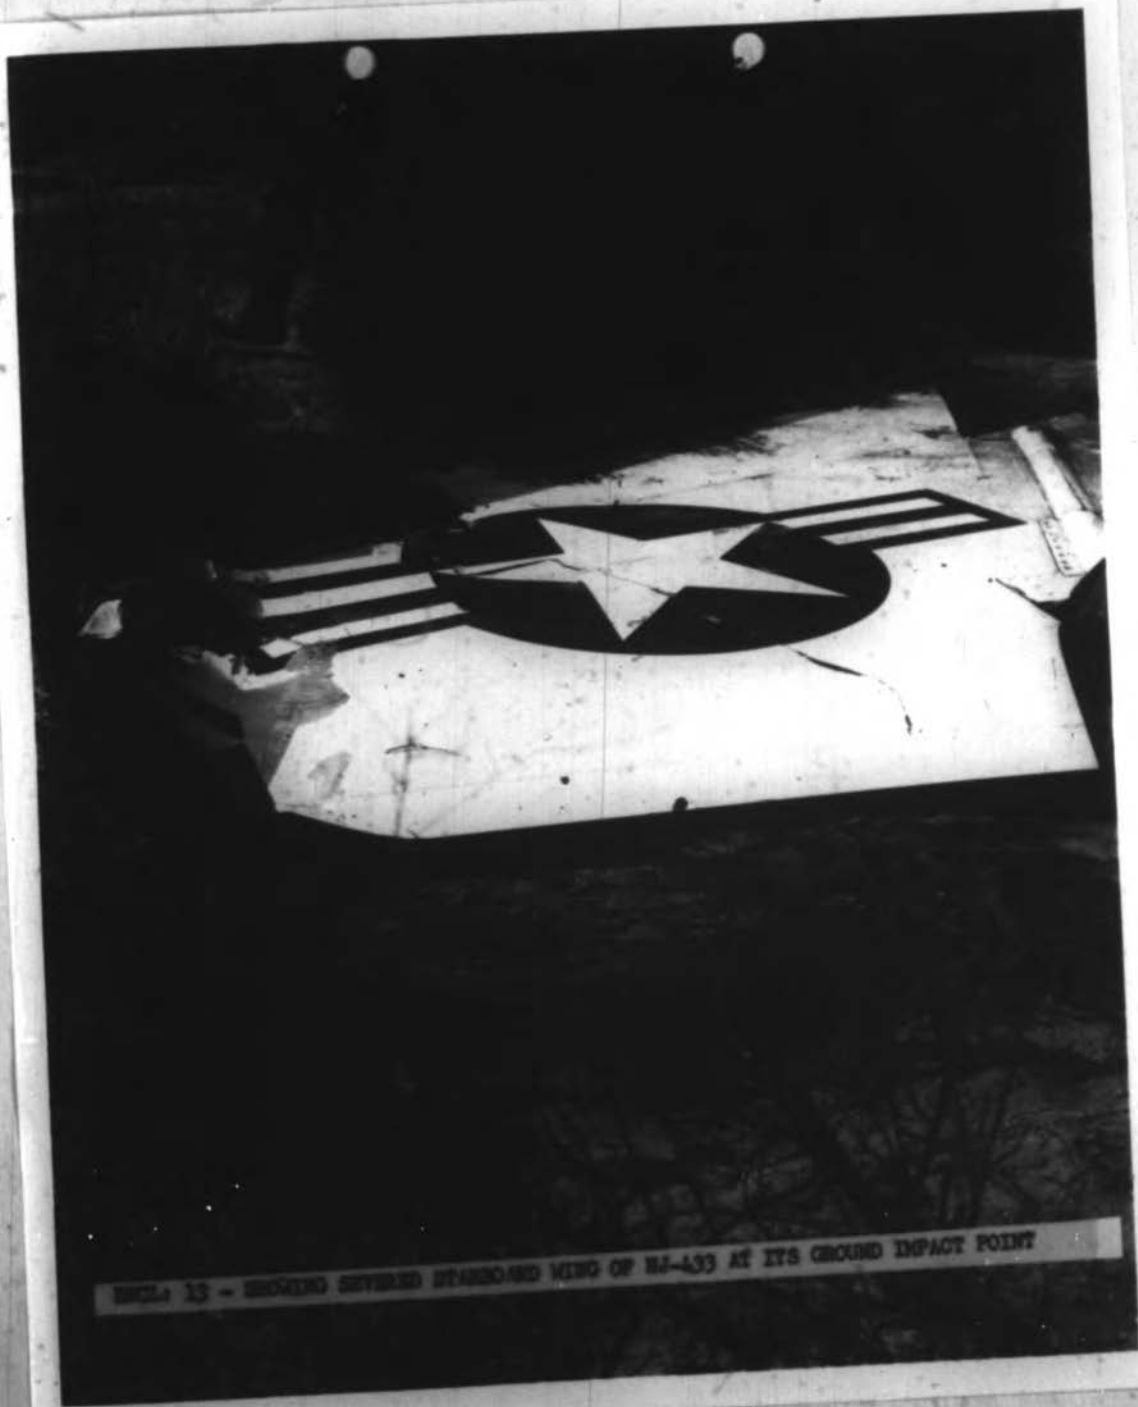
The starboard wing experienced extensive damage to the wing tip and leading edge which could have only occurred in flight. This statement is corroborated by the fact that no metal fragments were found in the wing impact area (Encl: 13) and red paint marks were found on the starboard wing. (Encl: 14) The damage to the leading edge therefore occurred inflight.

INCL: 13 - SHOWING SEVERED STARBOARD WING OF NJ-433 AT ITS GROUND IMPACT POINT

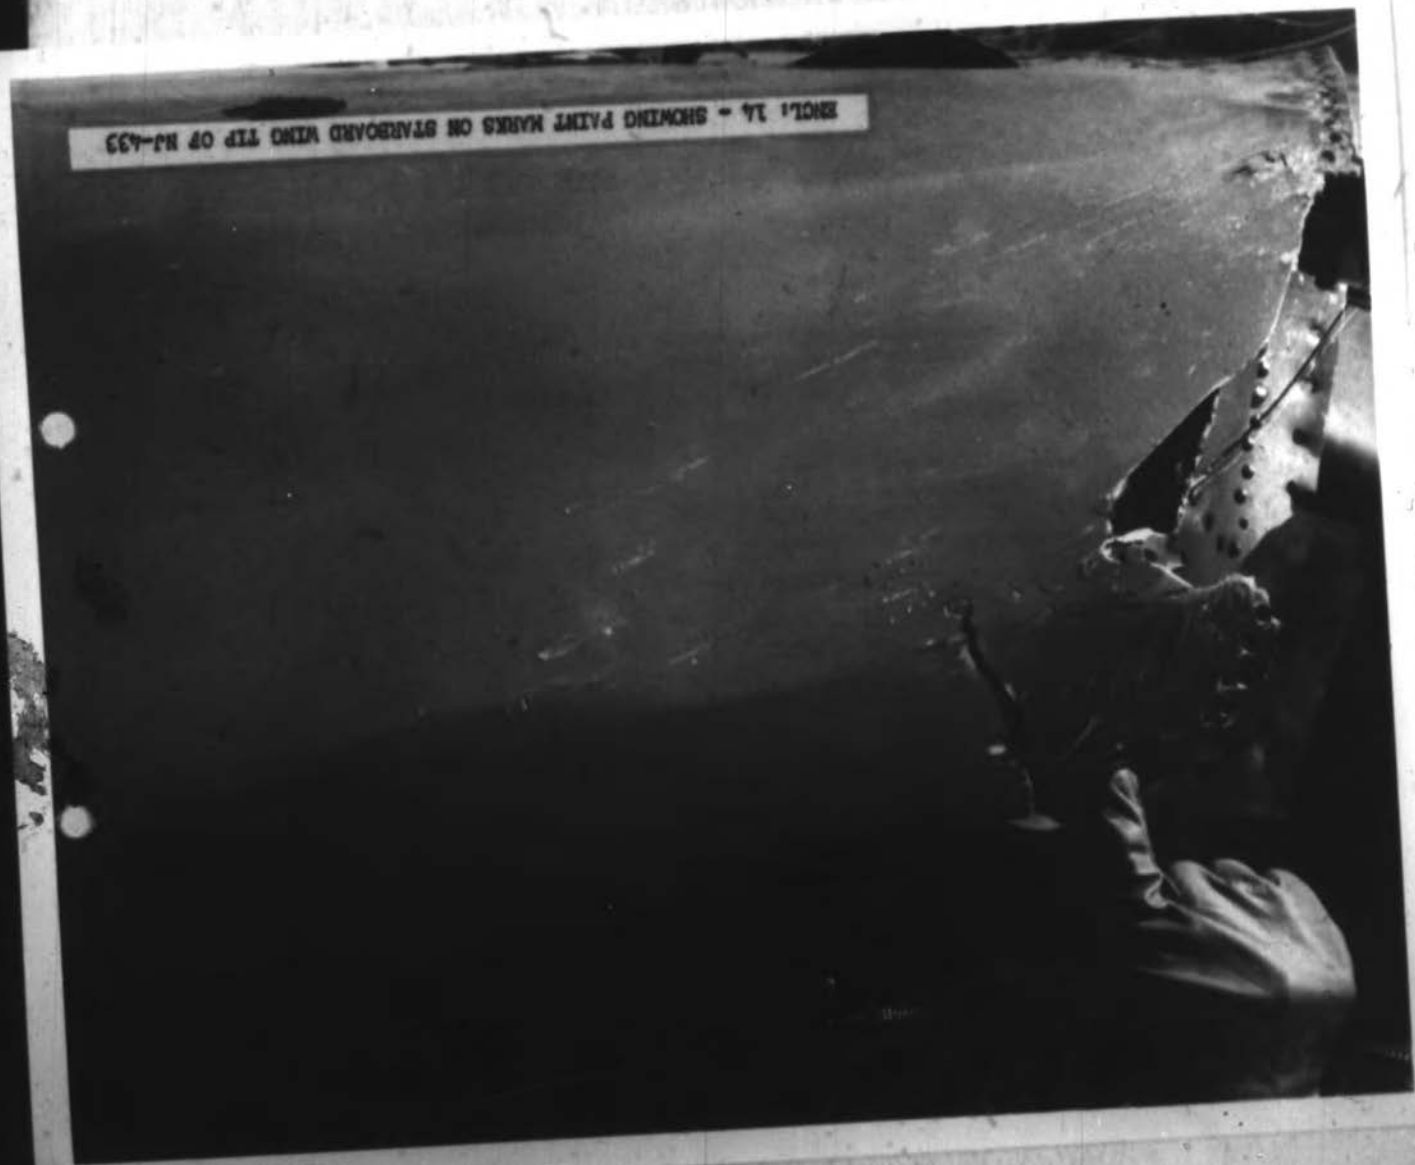
ENCL. 1A - SHOWING PAINT MARKS ON STARBOARD WING TIP OF H4-433

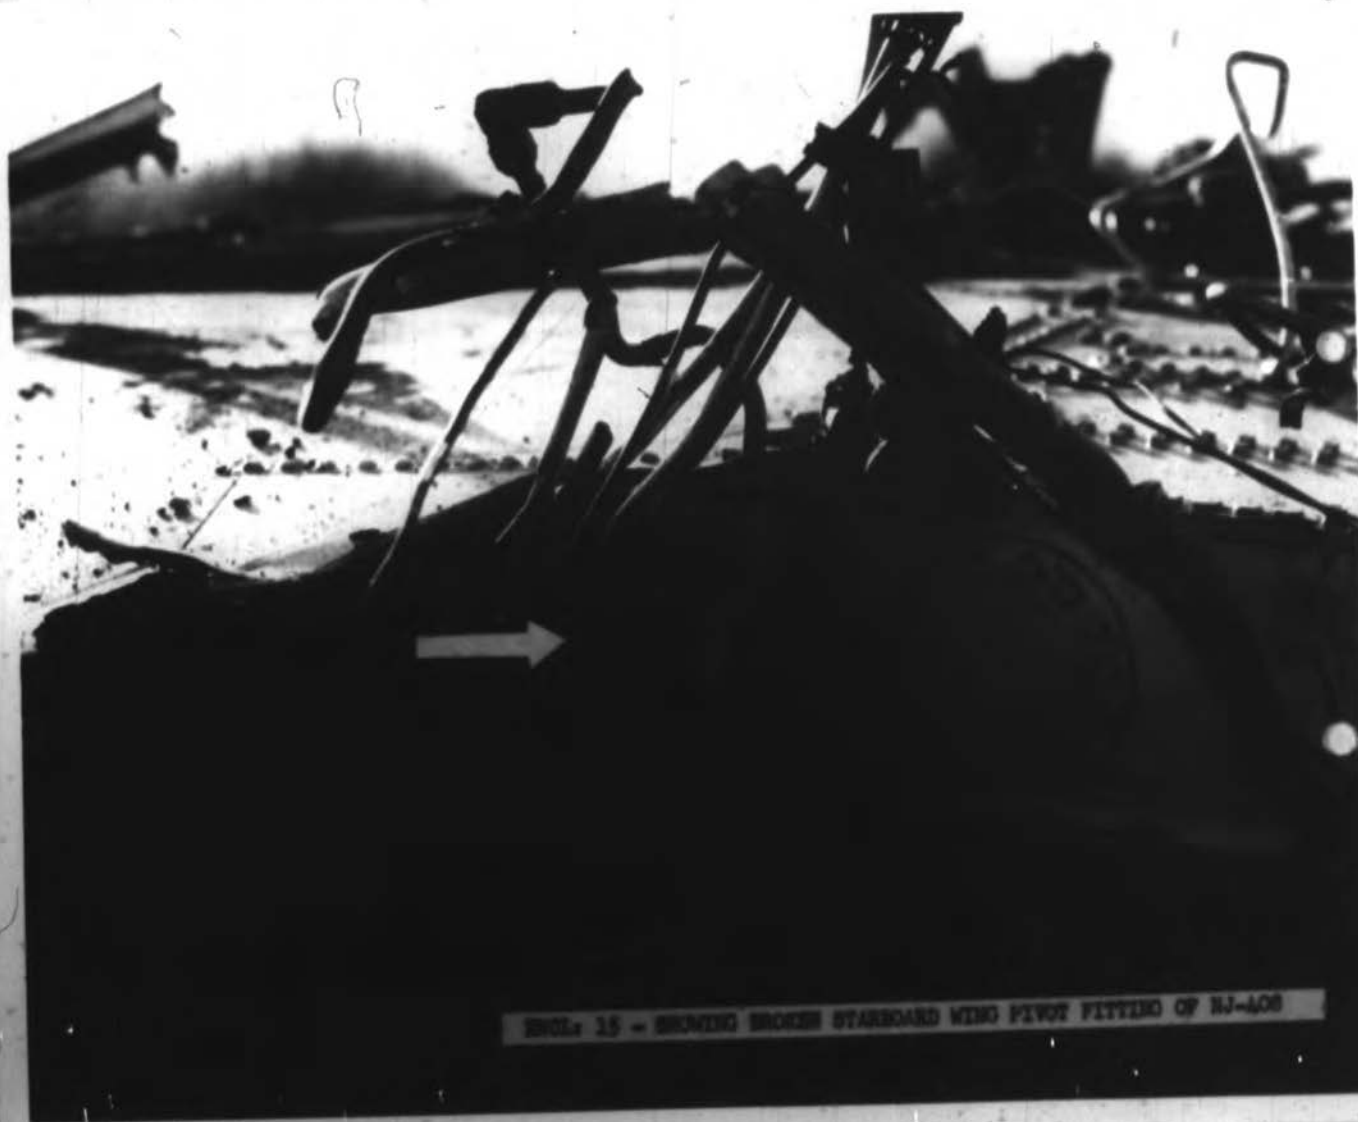
The starboard wing hinge pivot fitting of NJ-408 failed as a result of a load imposed on the rear of the starboard wing. (Encl: 15) The wing actuating rod failed due to shear loads imposed by counter-clock wise rotation of the wing about the aircraft yaw axis (Encl: 16) The port wing hinge pivot fitting remained intact, but the rotation of the wing tore the rib supporting the fitting out of the aircraft as the wing separated completely from the fuselage.

ENCL. 15 - BURNING BROKEN STARBOARD WING PIVOT FITTING OF HJ-408

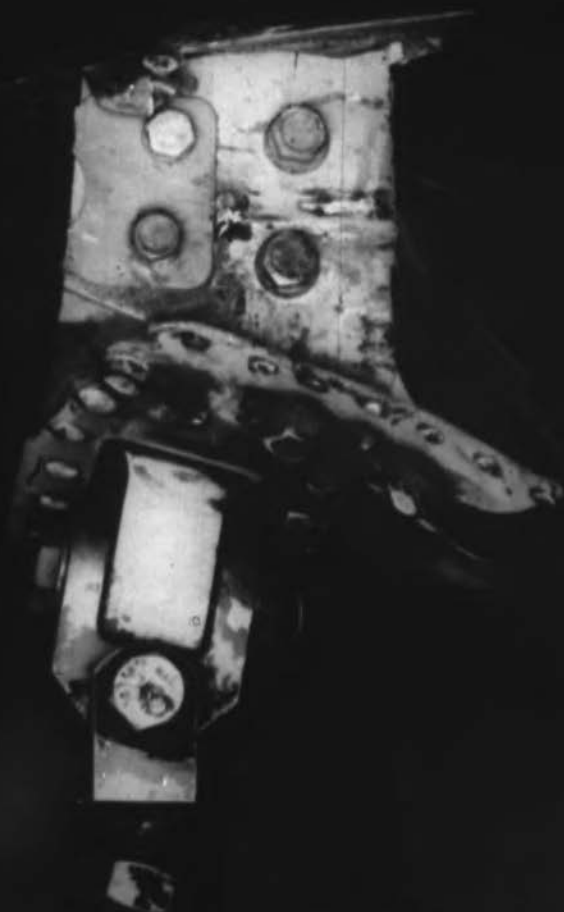
ENCL. 14 - SHOWING RESULT OF SIDE LOAD FORCES ON WING ACTUATING ROD OF FJ-408

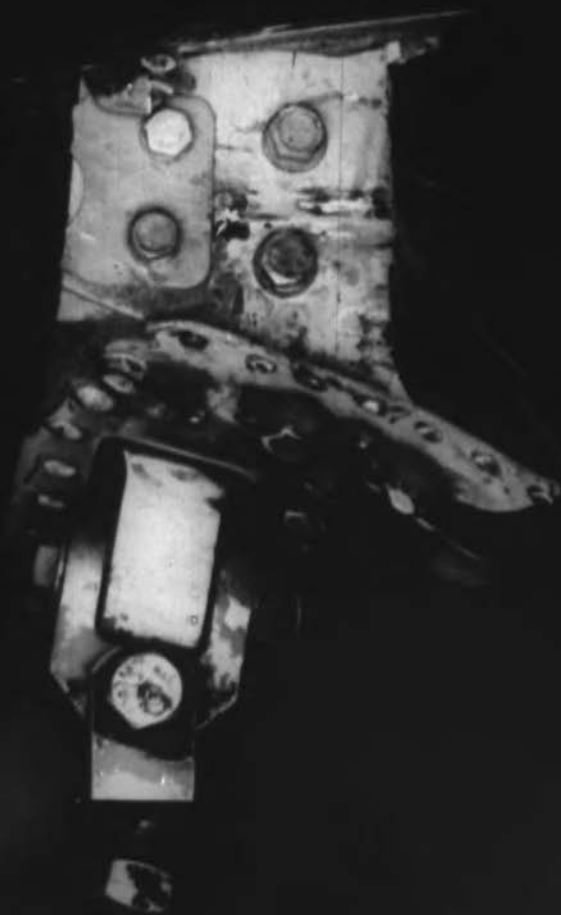
ENCL. 14 - SHOWING RESULT OF SIDE LOAD FORCES ON WING ACTUATING ROD OF HJ-408

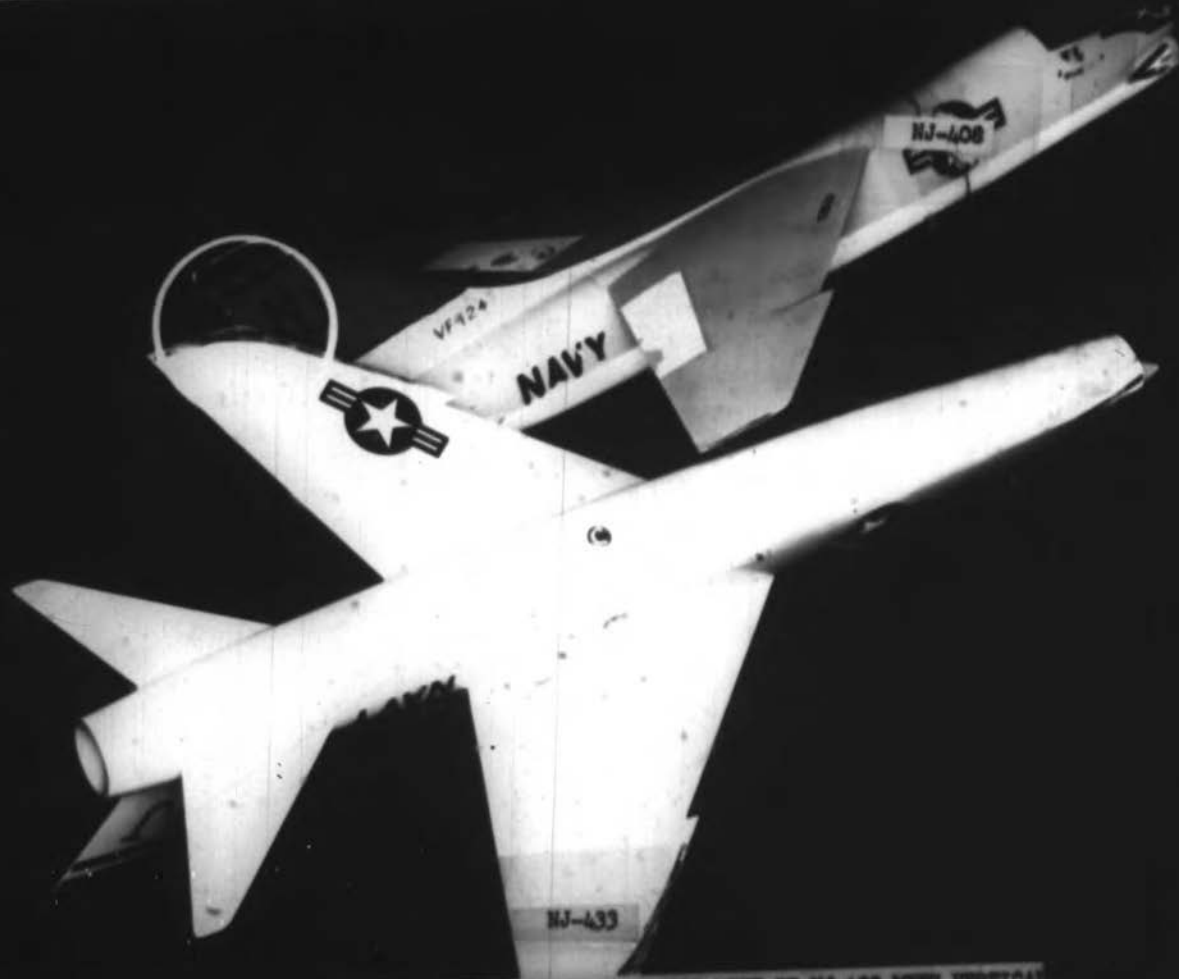
Initial impact was probably the fuselage of NJ-433 against the wing tip of NJ-408 (Encl: 17). NJ-433 was in a near inverted position, rolling left and ascending. The second impact was between the starboard wing tip of NJ-433 and the tail area of NJ-408, with NJ-433 in an inverted attitude and over taking NJ-408. (Encl: 18) The third and disabling impact was between the leading edge of the starboard wing of NJ-433 and the trailing edge of the starboard wing of NJ-408. (Encl: 19) This blow probably caused the wing of NJ-408 to separate from the fuselage and simultaneously break off the starboard wing of NJ-433 at the junction of the flap and the aileron. The simultaneous failure of both wings is substantiated by the wreckage distribution. The more dense portions of the wreckage, (fuselages of NJ-408 and NJ-433), were located to the north west. The entire wing of NJ-408 was located approximately 1 1/2 air miles south east of the fuselage while the starboard wing of NJ-433 was located 2 1/2 miles to the south east. The wreckage should be distributed along a north-west, south-east line, if the separation of the pieces occurred simultaneously, since the wind at altitude was from the north west. The wreckage distribution does lie about this line and thus verifies the theory that all pieces separated at nearly the same instant. (Encl: 20).

ENCL 2B - BOMBS IMPACTING IMPACT OF STARBOARD WING OF NJ-433 WITH VERTICAL
FIN OF NJ-408

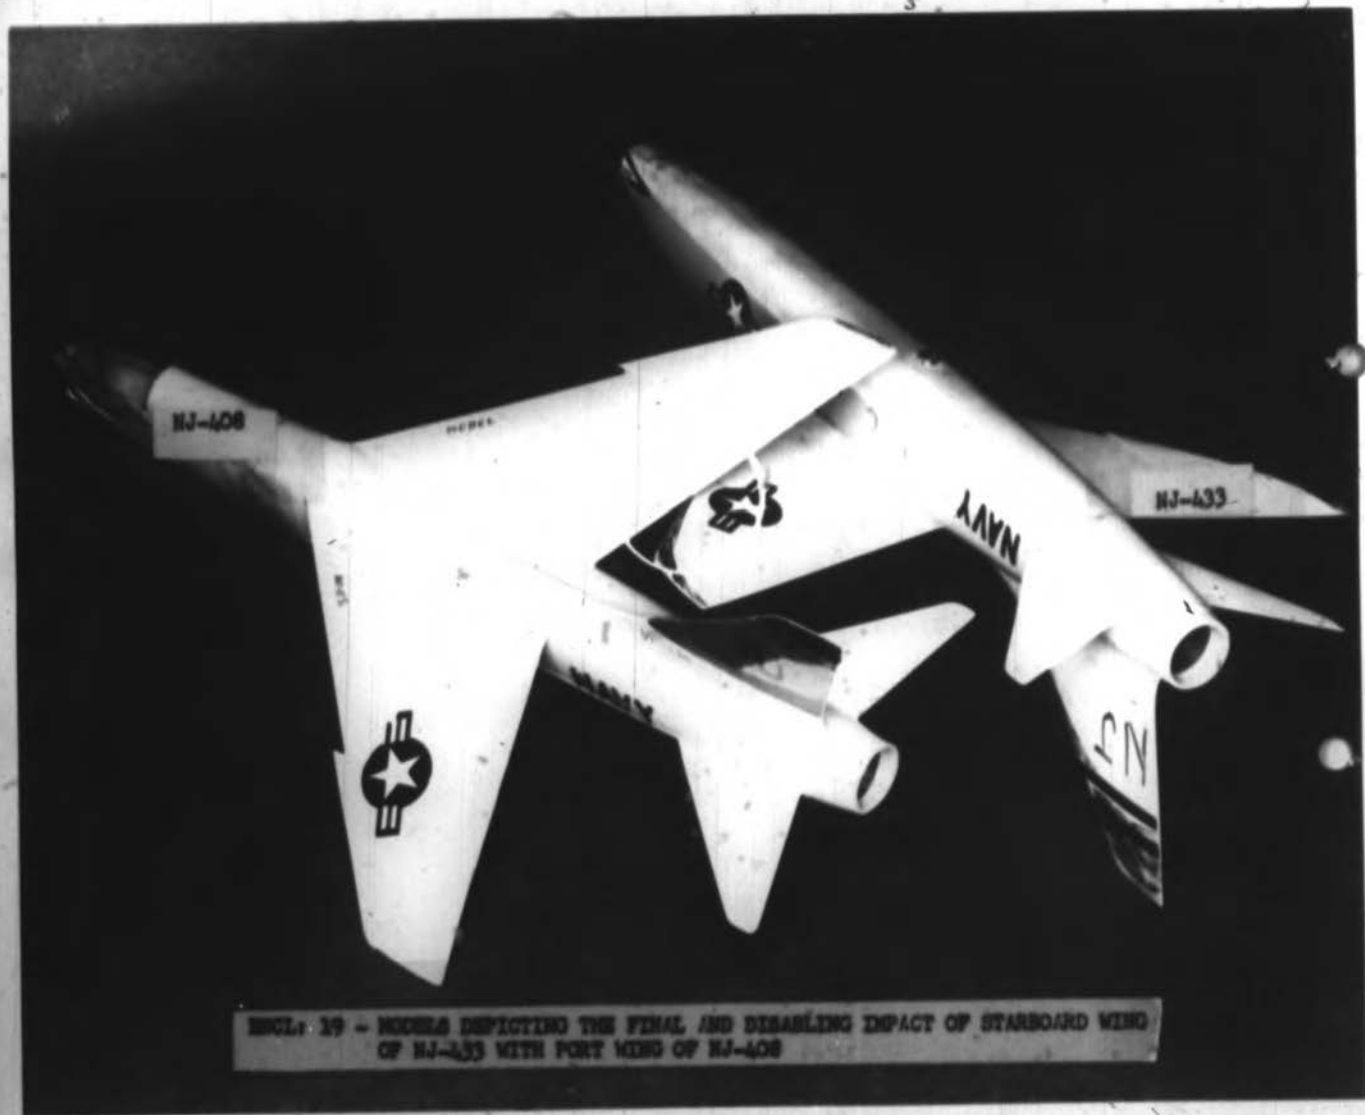
The damage to the leading edge of the starboard wing of NJ-433, the paint marks on the wing, the sequence of wing support failure, and the damage to the trailing edge of the starboard wing of NJ-408 indicate the collision of the starboard wing of NJ-433 with the trailing edge of the starboard wing of NJ-408. The concentration of damage on the starboard side of both aircraft establishes the fact that NJ-433 was inverted at the moment of collision.

ENCLOSURE 19 - PHOTOS DEPICTING THE FINAL AND DISABLING IMPACT OF STARBOARD WING OF NJ-433 WITH PORT WING OF NJ-408
